**NASA TECHNICAL
MEMORANDUM**

NASA TM X-52290

CENTAUR AC-6 NOSE FAIRING SEPARATION TESTS

by Jack C. Humphrey and Charles W. Eastwood, Jr.

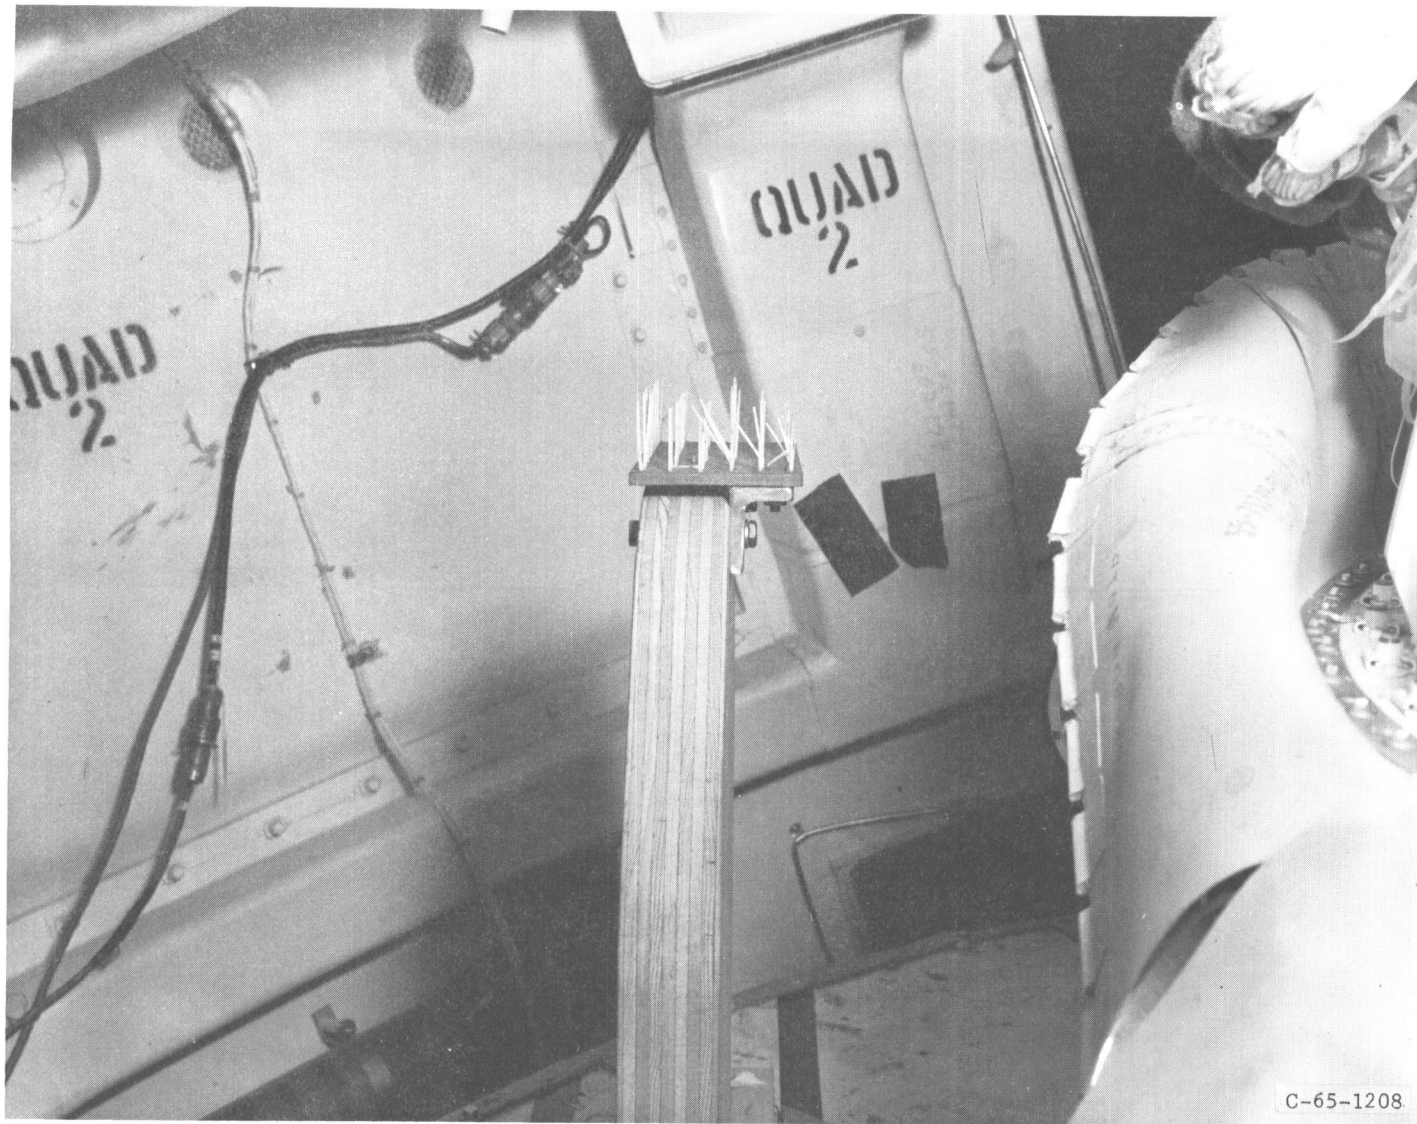
Toothpicks were broken on the guidance platform (as shown in figure 51) due to motions of the thermal bulkhead. The aluminum honeycomb on the payload envelope showed evidence of contact by the struts in the III and II quads, but no struts were broken. Figure 52 shows the crushed honeycomb caused by strut contact. The hinge pad fairing on the Quad I-IV half was broken during this test as shown in figure 53.

Figure 51. - Broken toothpicks on the guidance platform model after test IA-3.

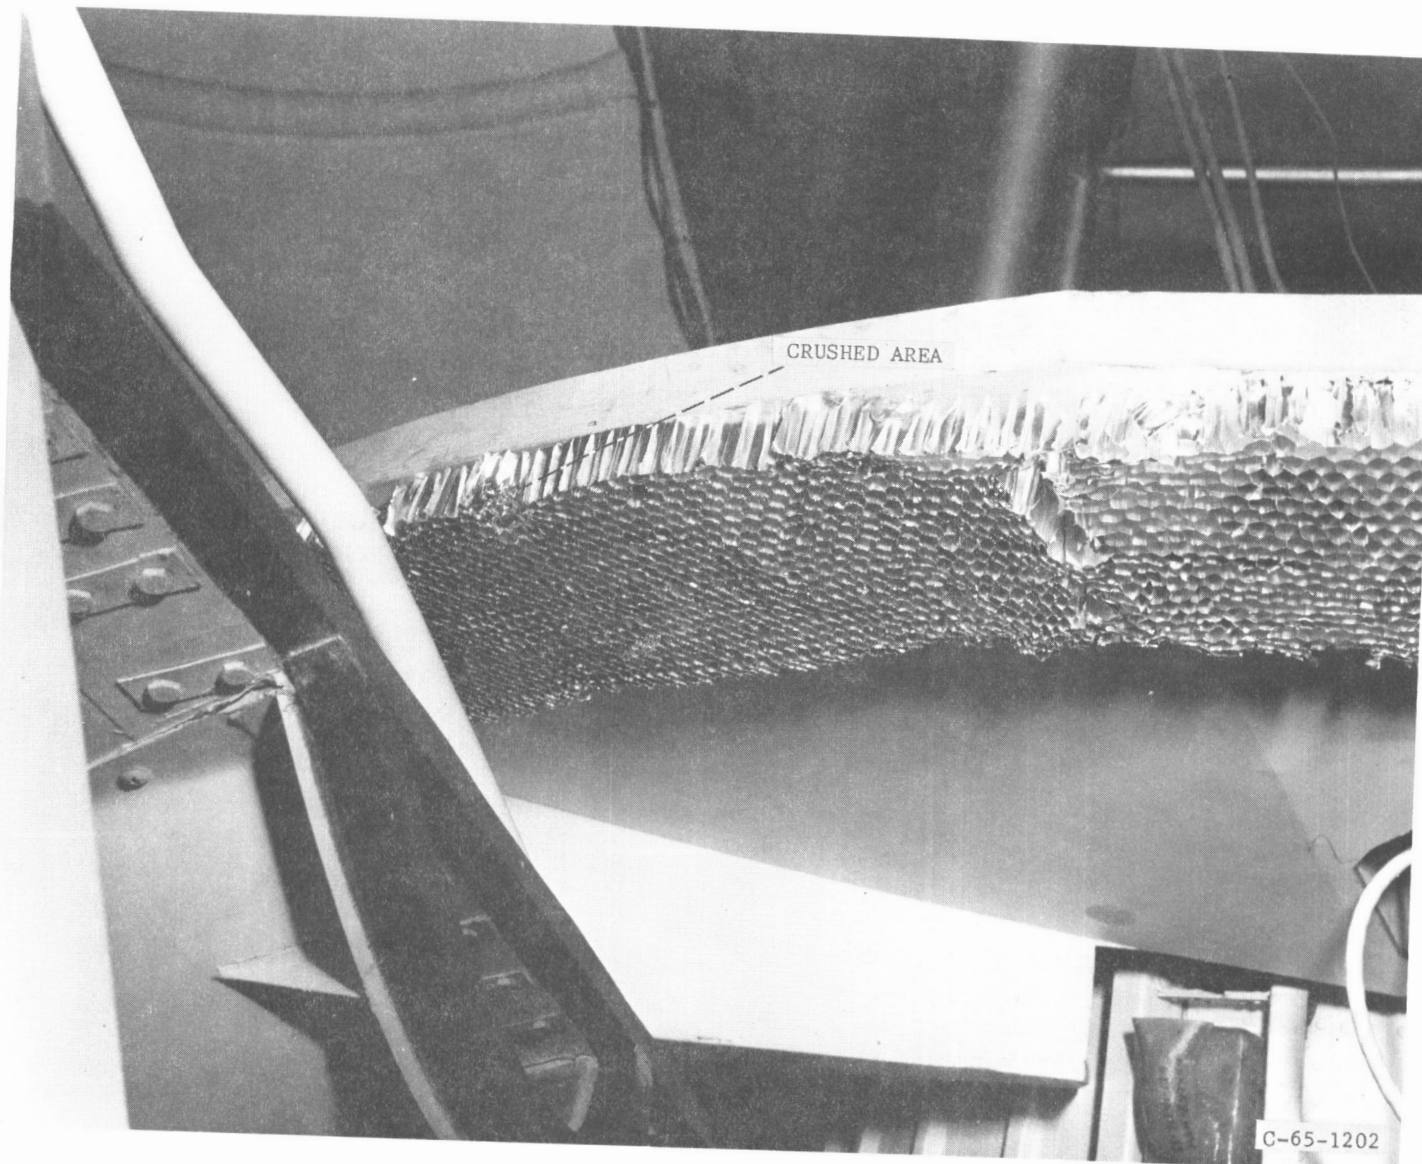
Figure 52. - Honeycomb installed on the Surveyor envelope model (Quad III), test LA-3.

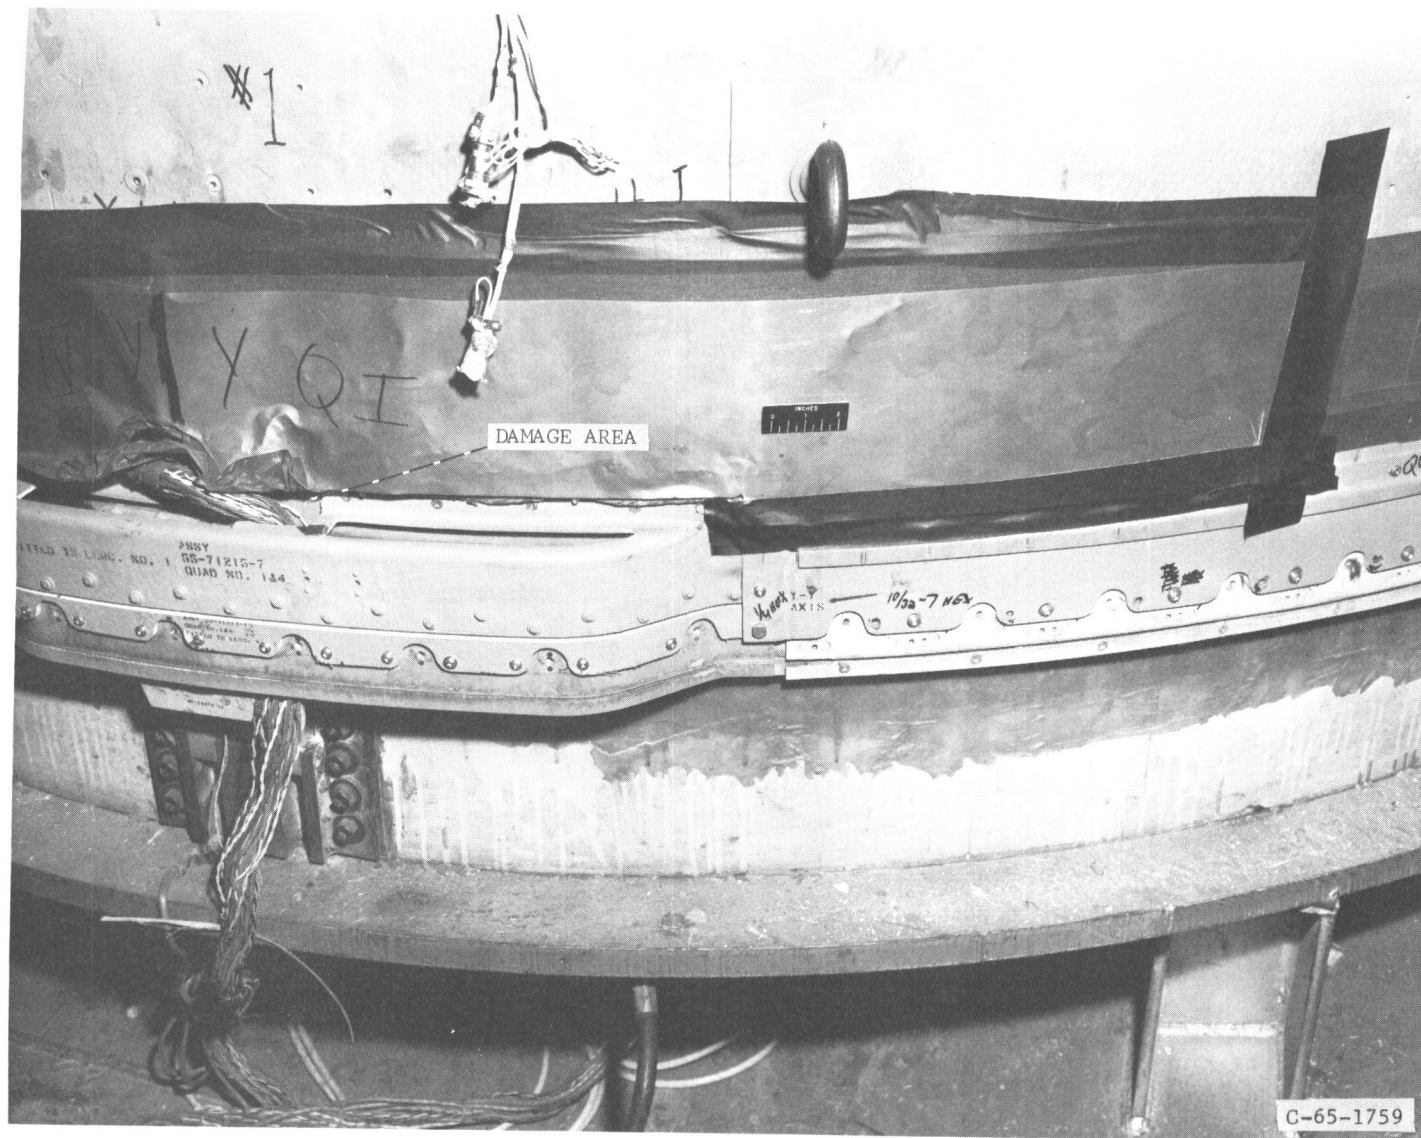
Figure 53. - Damage to the hinge pad fairing, test 1A-3.

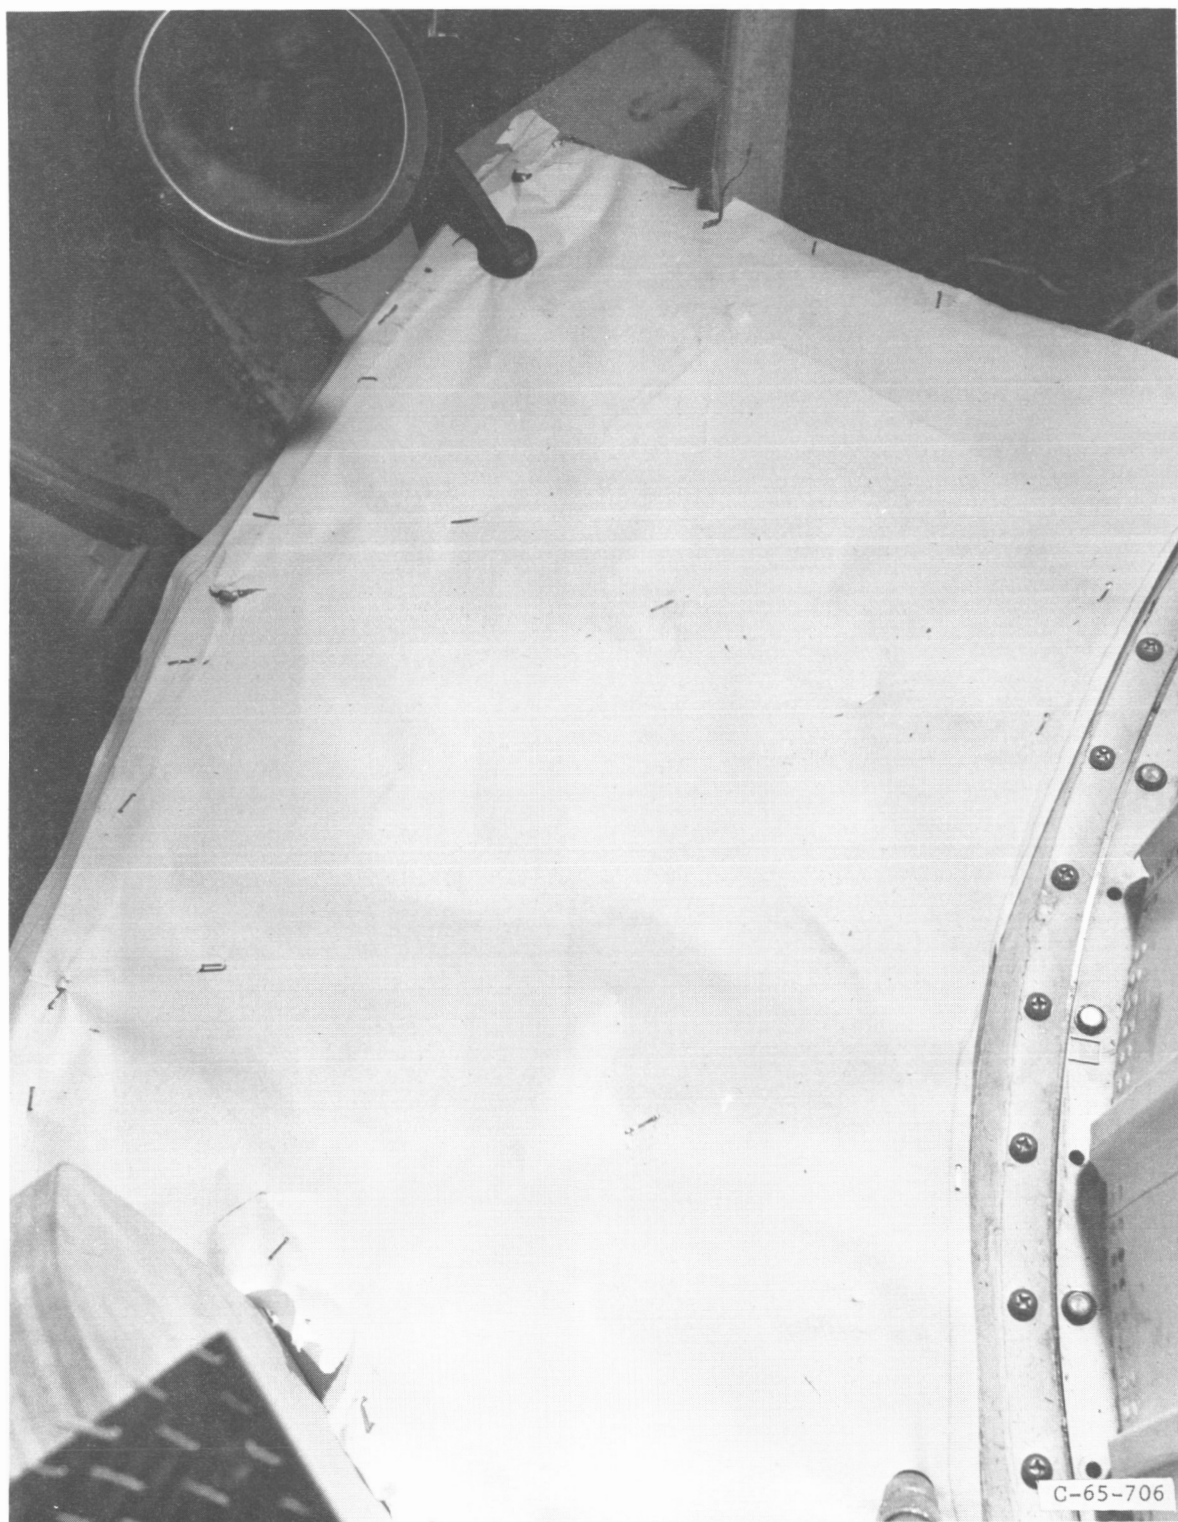
Figure 61. - Debris found on paper covering equipment shelf after test IA-1A.

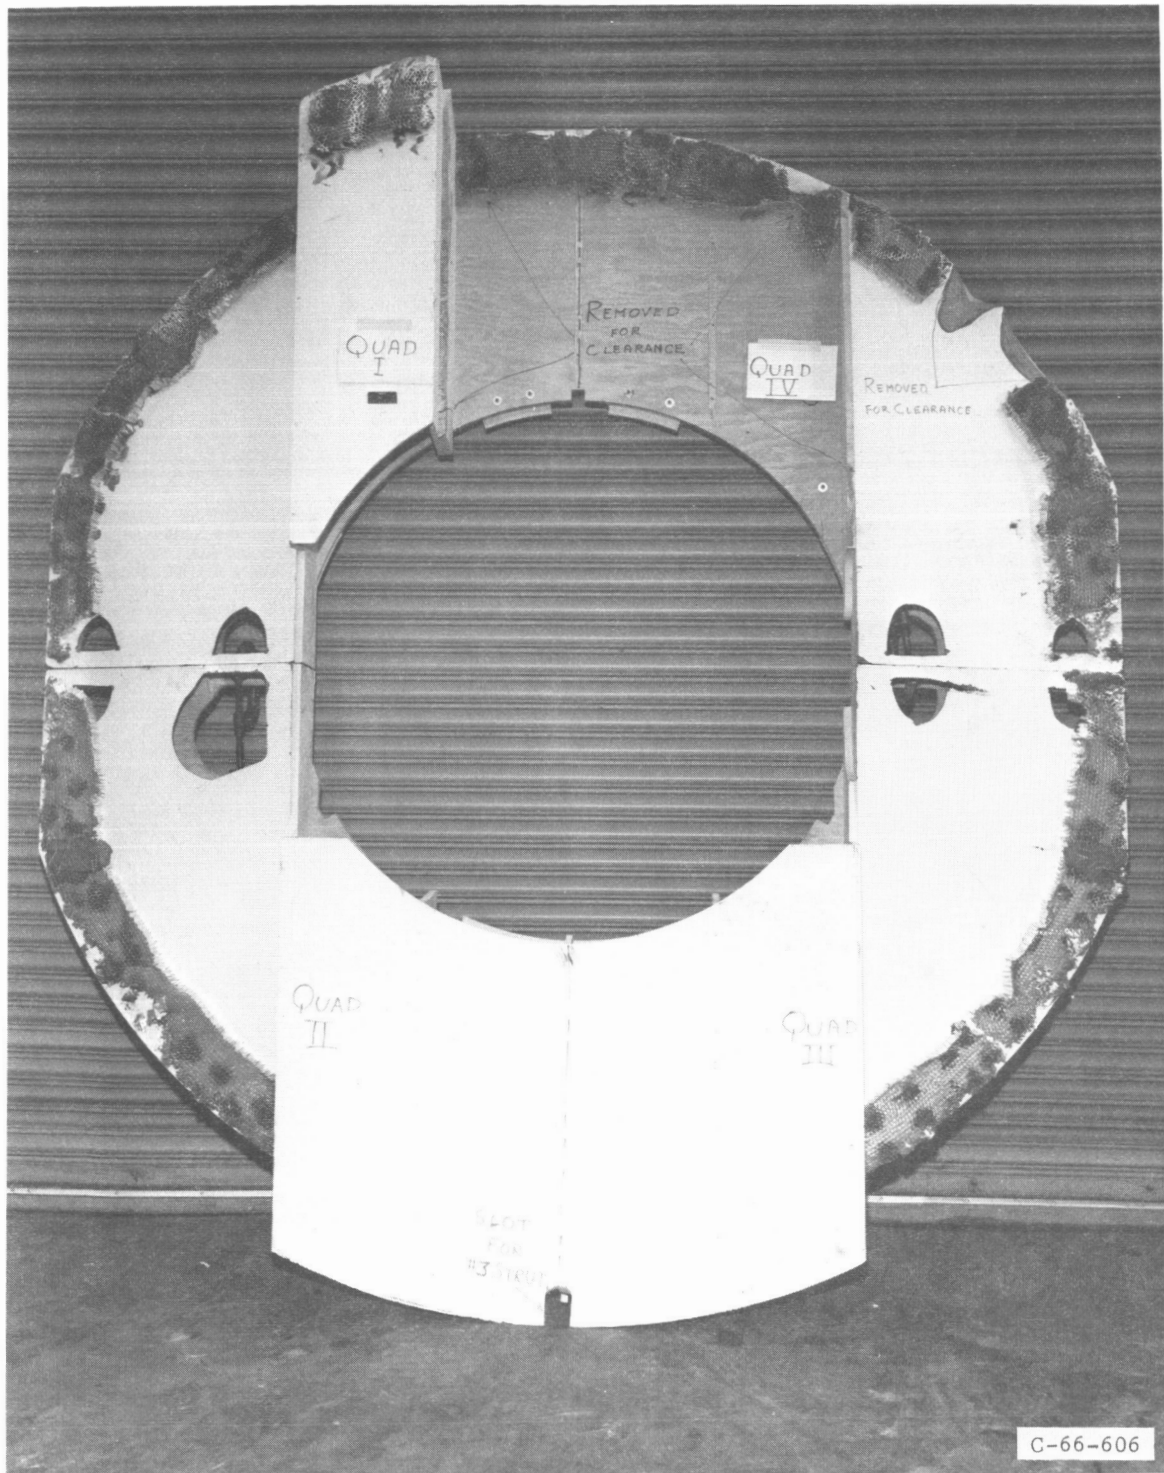
Figure 69. - Model of the Surveyor envelope and required changes.

of the envelope located at station 135 and in the YY axis area. It was also necessary to cut the edge of the envelope back about 2 inches, and for a length of 4 inches around the circumference directly above the air conditioning duct (enlarged section located on top of the thermal bulkheads). These clearances were necessary only during the assembly operation and would not be needed if the assembly were made using the fixtures provided for in flight assembly. Figure 41 shows the installation on the payload adaptor and modifications to the envelope model.

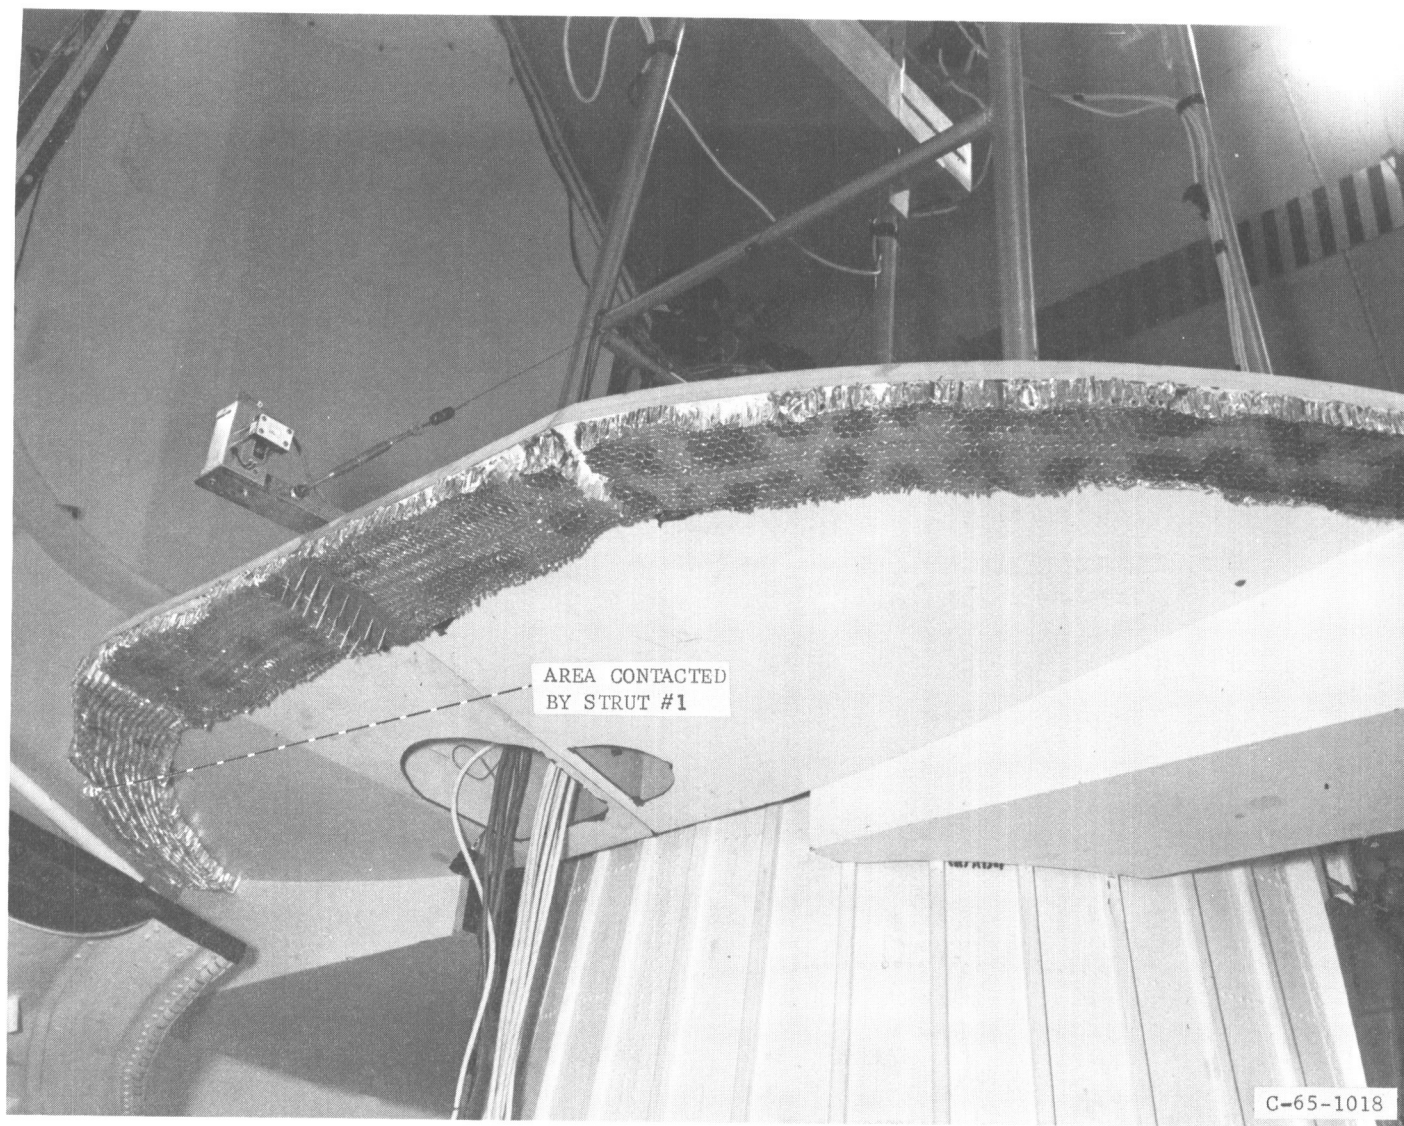
Strips of 1 inch thick aluminum honeycomb were glued to the bottom of the envelope in the areas where the struts were expected to be the closest during jettison to provide evidence of any contact between the struts and the envelope. During jettison test LA-2D (first separation test after installation of the envelope), strut No. 1 was broken. The honeycomb covering the suspected contact area on the envelope near this strut was crushed at three spots as though the strut had nearly contacted the envelope two times before it finally hit the envelope and broke the strut. (Figure 70 shows the area of contact). The honeycomb in the suspected contact areas for struts No. 5 and No. 6 also was crushed. These crushed areas indicated that the struts must have been within 0.5 inch of contact. No struts in these areas were broken in future tests although the honeycomb in the II and III quads showed evidence of near contact in both tests LA-3 and LA-4. Figure 41 shows the honeycomb installation after Test LA-2D in the area above strut No. 1. Figure 45 shows the strut broken during test LA-2D. A strut located in No. 3 position (YY axis envelope cut out) was broken during test LA-4A but examination of the edge of the envelope model showed that it had been hit in a position slightly to one side of the strut clearance slot and it was concluded that the fairing had hit the facility catcher, rolled, and bounced back far enough for the strut to hit the unslotted area of the envelope.

Figure 70. - Honeycomb on the envelope model after test IA-2D.
